Fillmore Burn Dump

SWIS #56-CR-0016

Post Closure Land Use Plan

Prepared September 2014
Updated May 2015

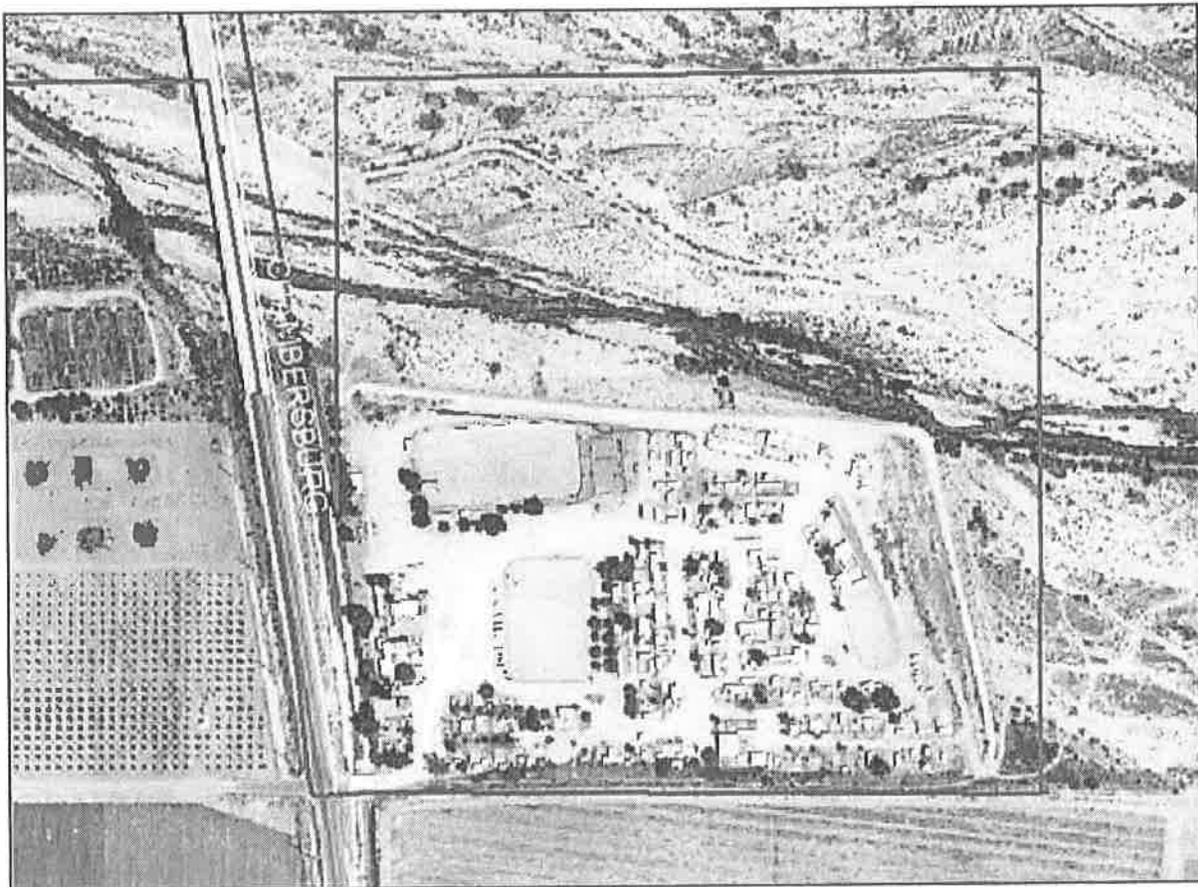
Figure 1 - Former Fillmore Open Burn Dump Site

The site is located adjacent to the south bank of the Santa Clara River and east of State Route 23 (SR-23) also known as Chambersburg Road. The site is part of a large land parcel that extends into the Santa Clara River bottom owned by the City as indicated by the City Limit shown in red above. Adjacent land uses are either agricultural fields or river bottom.

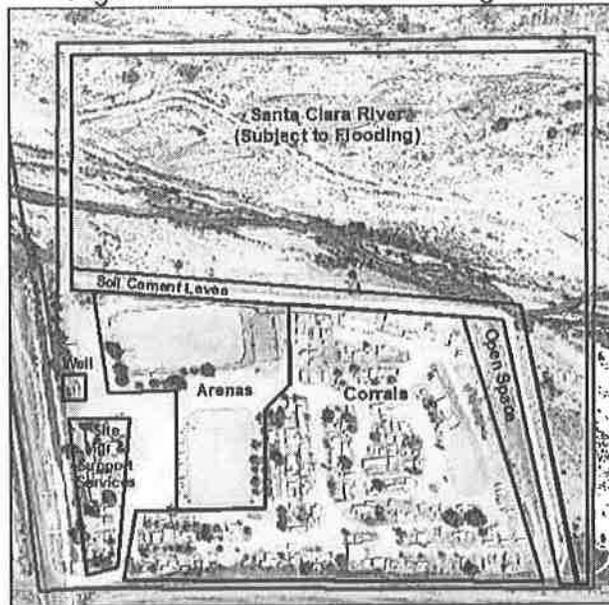
Figure 2 – Land Use of Existing Site

- a. Postclosure land use – The site has been minimally improved and has been used as an equestrian center for the boarding of horses for the past 36 years and that use is expected to continue into the foreseeable future. Should that use be discontinued, the site would most likely revert to non-irrigated open space. However, should any other more intensive land use be contemplated the City will seek regulatory review and approval before initiating that use.
- b. Site design – The site has minimal improvements at this time, basically one small step above open space as illustrated in Figure 2 below. By the very rural nature of its use, the site harmonizes in all respects with the setting and harmonizes with the surrounding land uses.

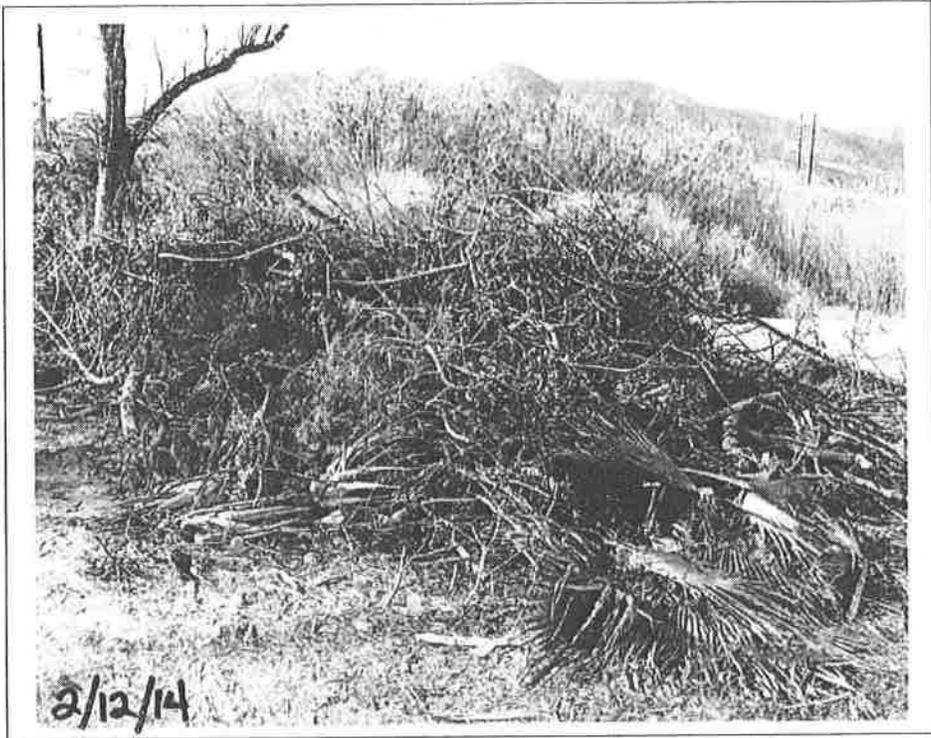
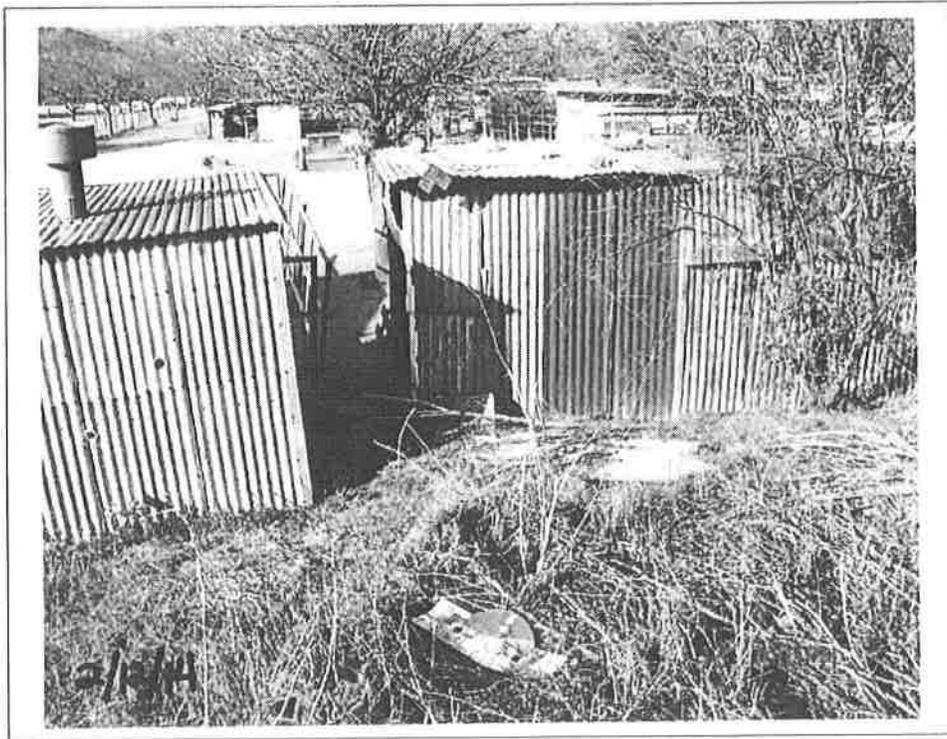
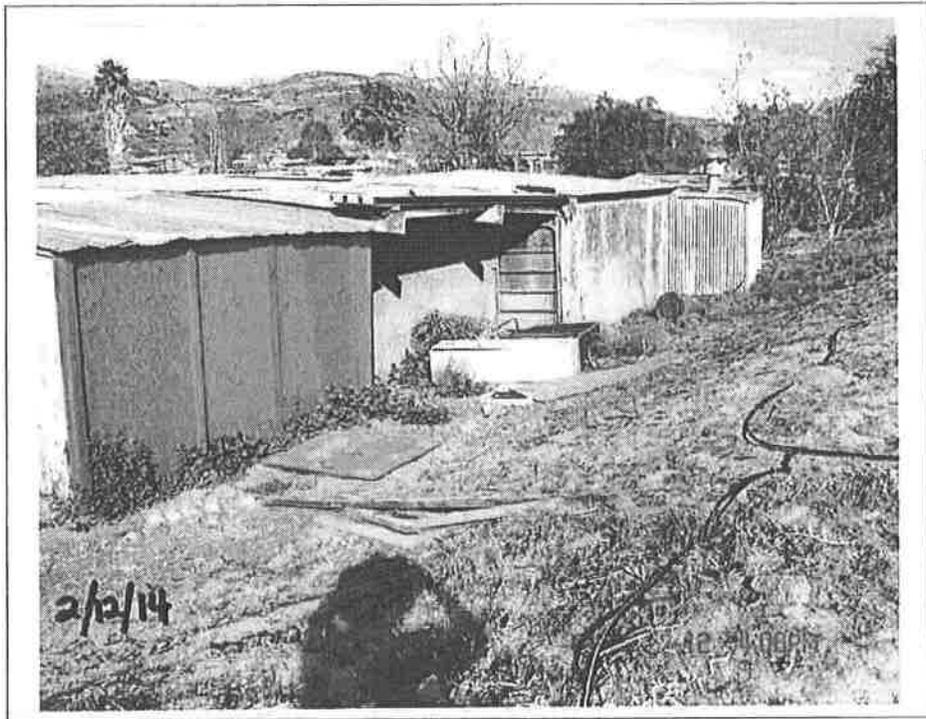
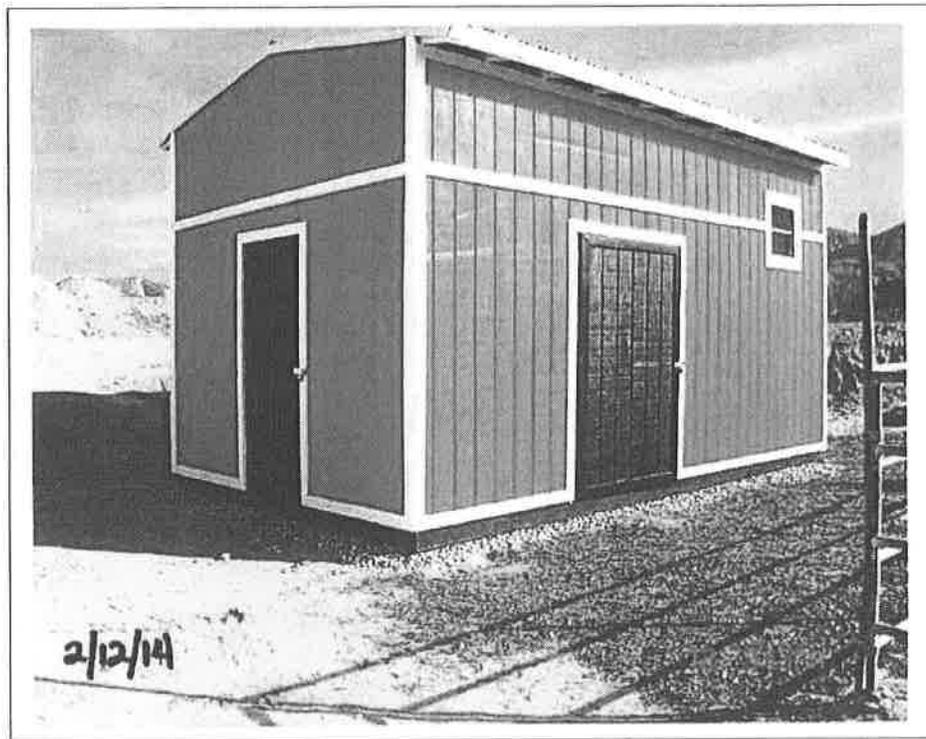
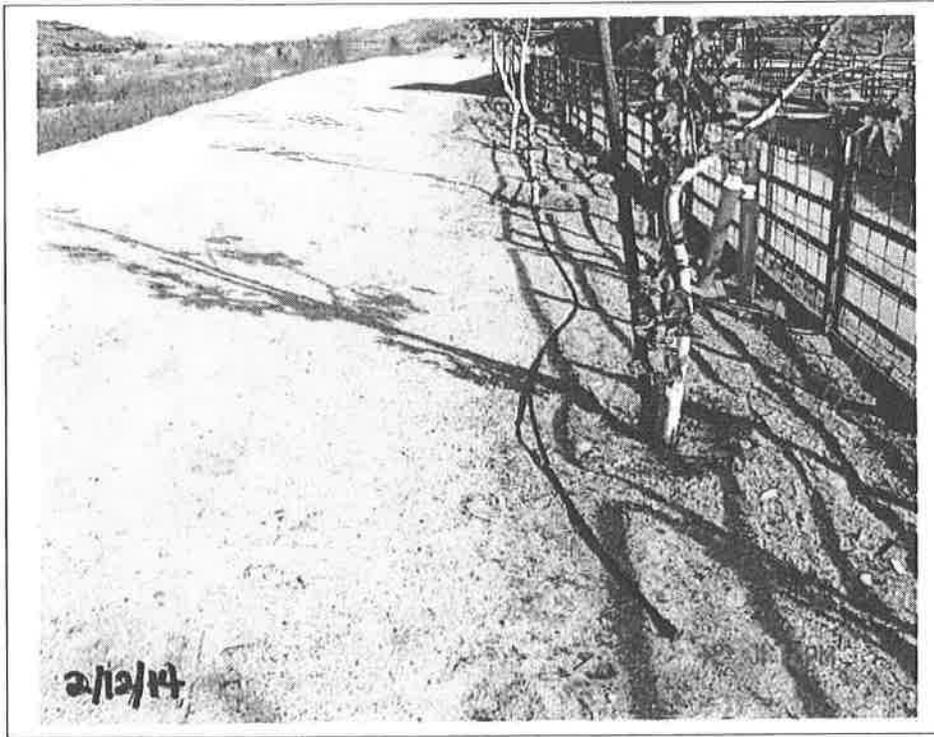
Inspection Report Comments:			
<p>The first quarter 2014 routine LEA inspection was performed February 12, 2014. The weather was clear, warm and with a slight breeze.</p> <p>The site use remains significantly unchanged since the last routine LEA inspection and is used as an equestrian center. The site contains riding arenas, stables, cattle pens, horse trailers, storage buildings and two mobile homes (raised above grade). No daylighting of waste was observed. The site is open to the public via an access road on the southwestern portion of the disposal site.</p> <p>See above for the noted areas of concern and corrective actions required.</p>
